Re: Continental House #606 AIC Testing (#P26035A)

APPARENT IMPACT INSULATION CLASS (AIIC) TEST REPORT

Conducted for:	Irene Ferrante
CENSEO Test #:	26035A-01
Test Date:	May 18, 2026
Report Date:	May 19, 2026
Test Location:	Continental House Condominiums
Test Description:	Floor/Ceiling Assembly between Unit 606 and Unit 506

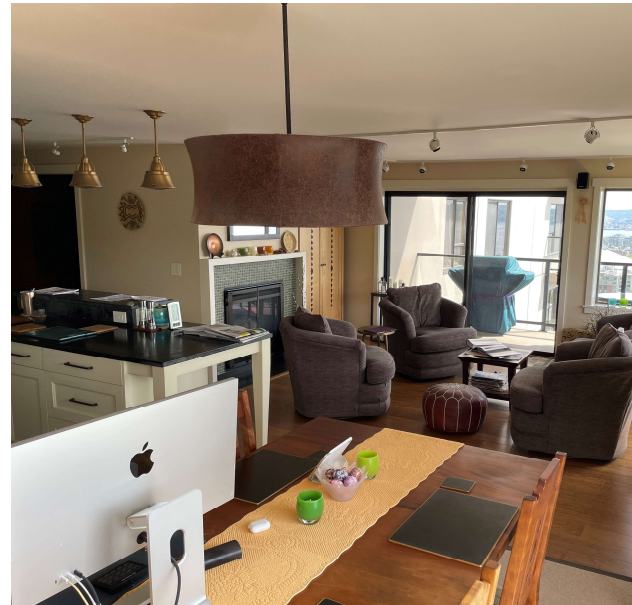
Figure 3:
 Receiver Room Test Environment

Table 4: RECEIVER Room Description	
Location:	Unit 506 Living / Dining / Kitchen
Finishes (Walls & Ceilings):	Gypsum board, doors, lighting, window
Finishes (Floor):	Wood flooring
Furnishings:	Upholstered furniture, dining table & chairs, wood cabinets

Table 5: Test Area and Dimensions	
Test Partition Size:	Approximately 5' x 5' mock-up flooring area
Receiver Room Size:	440 sq. ft.
Receiver Room Ceiling Height:	7'-7"
Receiver Room Volume:	3,113 cu. ft.
Notes:	1. Cabinet volumes deducted from receiver room volume 2. Corridor beyond kitchen area excluded from receiver room measurements

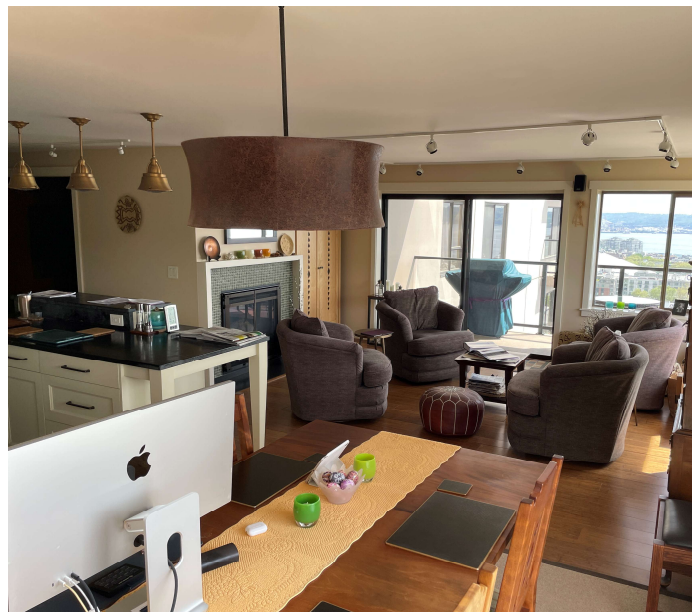
Figure 3:
 Receiver Room Test Environment

Table 4: RECEIVER Room Description	
Location:	Unit 506 Living / Dining / Kitchen
Finishes (Walls & Ceilings):	Gypsum board, doors, lighting, window
Finishes (Floor):	Wood flooring
Furnishings:	Upholstered furniture, dining table & chairs, wood cabinets

Table 5: Test Area and Dimensions	
Test Partition Size:	Approximately 5' x 5' mock-up flooring area
Receiver Room Size:	440 sq. ft.
Receiver Room Ceiling Height:	7'-7"
Receiver Room Volume:	3,113 cu. ft.
Notes:	1. Cabinet volumes deducted from receiver room volume 2. Corridor beyond kitchen area excluded from receiver room measurements
